2 BEAR GAP NO. 6

4 PHASE I INSPECTION REPORT

1 NATIONAL DAM INSPECTION PROGRAM

15
DACW32-78-C-0044
Prepared For
DEPARTMENT OF THE ARMY
Baltimore District, Corps of Engineers
Baltimore, Maryland

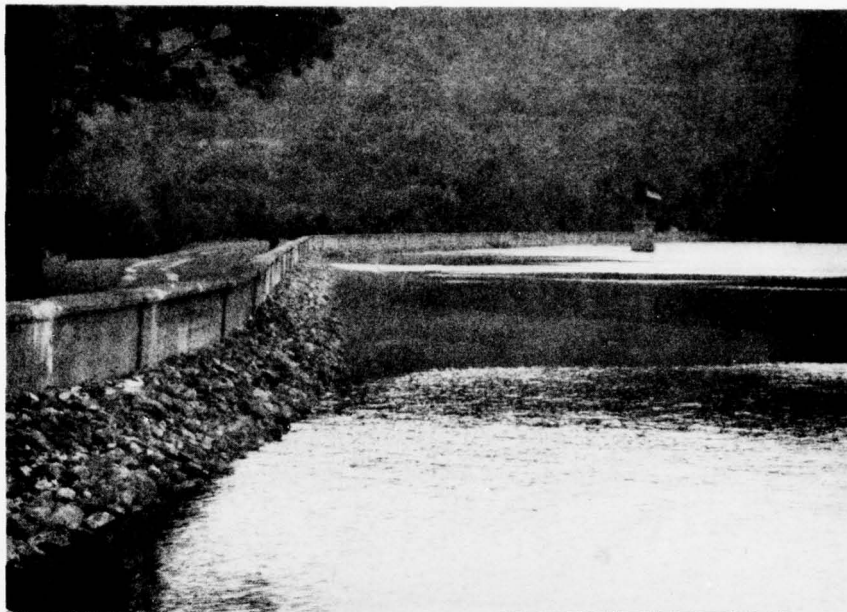
The horizontal alignment of the dam is curved at the south end (left abutment). The top of the dam is 32 feet wide (Appendix D, Plate VI) and has a 3 foot high concrete parapet on the upstream side. The parapet appeared to be maintained in excellent condition. The upstream slope is protected by riprap and did not show any irregularities. The downstream slope has a good grass mat and is mowed at regular intervals. Some seepage and wet spots were detected during the inspection. See schematic plan in Appendix D for appropriate location. The amount of seepage was not considered excessive and no transportation of fines was noted. Mr. Douglas McWilliams, owner of the company, stated in a phone conversation that these areas dry out in the summertime.

Dam
Looking North

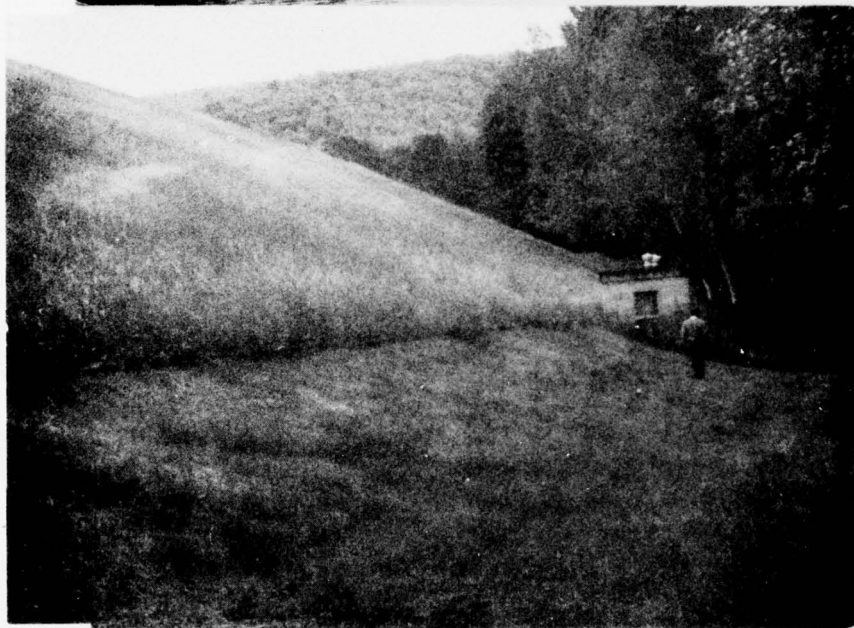
There were no visual indications of undue embankment stresses or sloughage. Except for a small amount of seepage near the left abutment just above the roadway leading to the valve house (Appendix D, Plate VII) the embankment was in good condition. A small amount of leakage was also detected about 50 feet beyond the toe of the dam, north of the valve house and located in a wooded area.

Downstream Slope
and Valve House

1. The owner shall make a detailed hydrologic and hydraulic analysis for these facilities and improve the spillway capacity to meet the requirements found by this analysis.
2. The owner shall monitor the seepage occurring at this dam. If seepage increases or if turbidity is discovered in the seepage water, or embankment sloughage is detected, immediate remedial measures shall be taken.

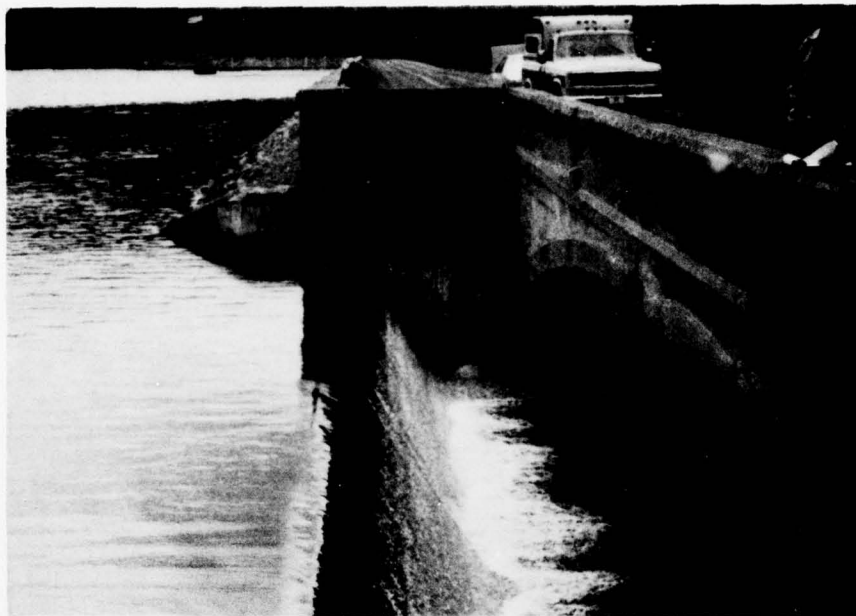
The appurtenant structures all appear to be in good condition. An arch bridge is located across the spillway just below the ogee section (Appendix D, Plate IV). The spillway had been heavily damaged during tropical storm Agnes in June, 1972. The damage started about 200 feet downstream from the ogee section. The spillway chute was redesigned and construction was completed in 1975. Photographs on Plate IV and V show the new spillway channel and energy dissipators.

Spillway

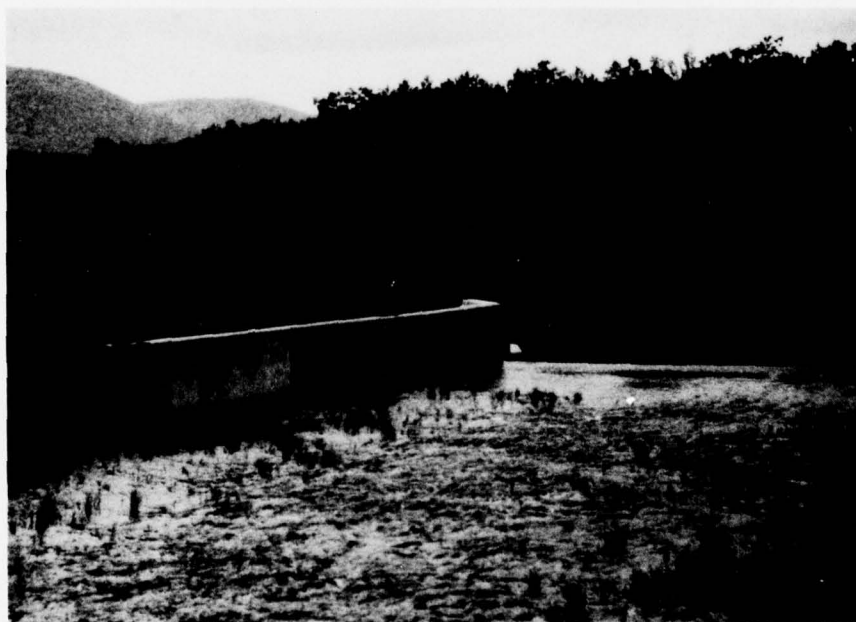
Visual observations indicate no present stability or stress problems in any of the appurtenant structures. A small amount of spalling has occurred on the spillway walls near the spring line of the arch bridge.

Spillway
Below Bridge

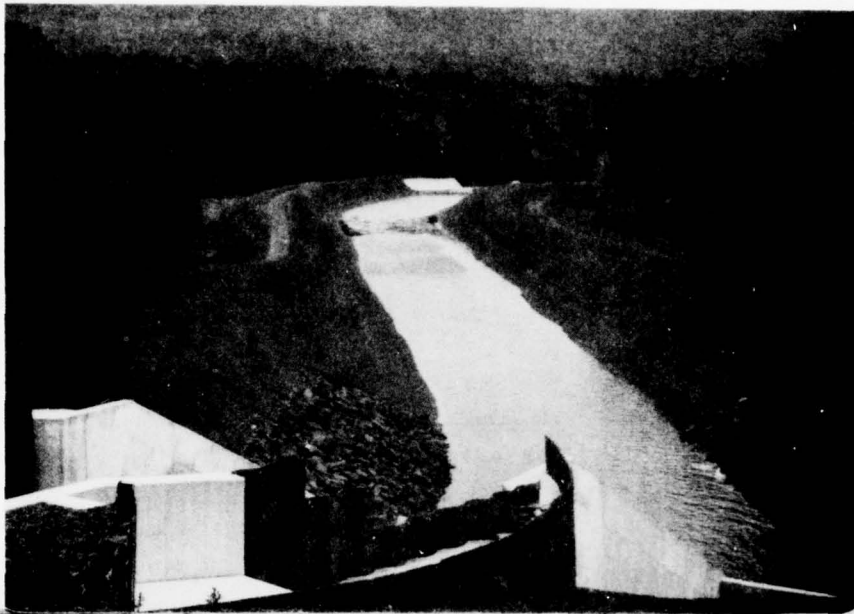
A new channel with a stone bed and dikes was constructed in 1973. There are two locations with steep drops and energy dissipators. Below the last drop structure the water enters the natural channel which is sufficiently wide and clear. The Bear Gap No.2 Dam (NDS #816) is about 4.4 miles downstream and just below that dam is the intake dam. Farther downstream several homes and farm buildings are located within the flood plain. Failure of this dam would cause overtopping and possible failure of Bear Gap No.2 Dam. Although no persons are living near the stream between the two dams, the successive failure of both dams would cause loss of life of more than a few and an appreciable economic loss. The hazard classification for this dam is considered to be "High".

Spillway
Channel

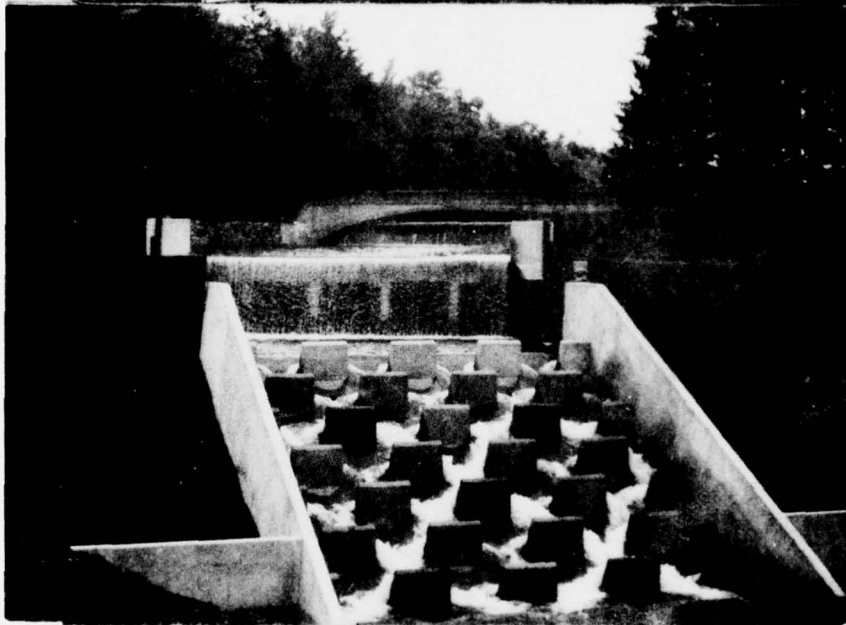
Energy
Dissipators

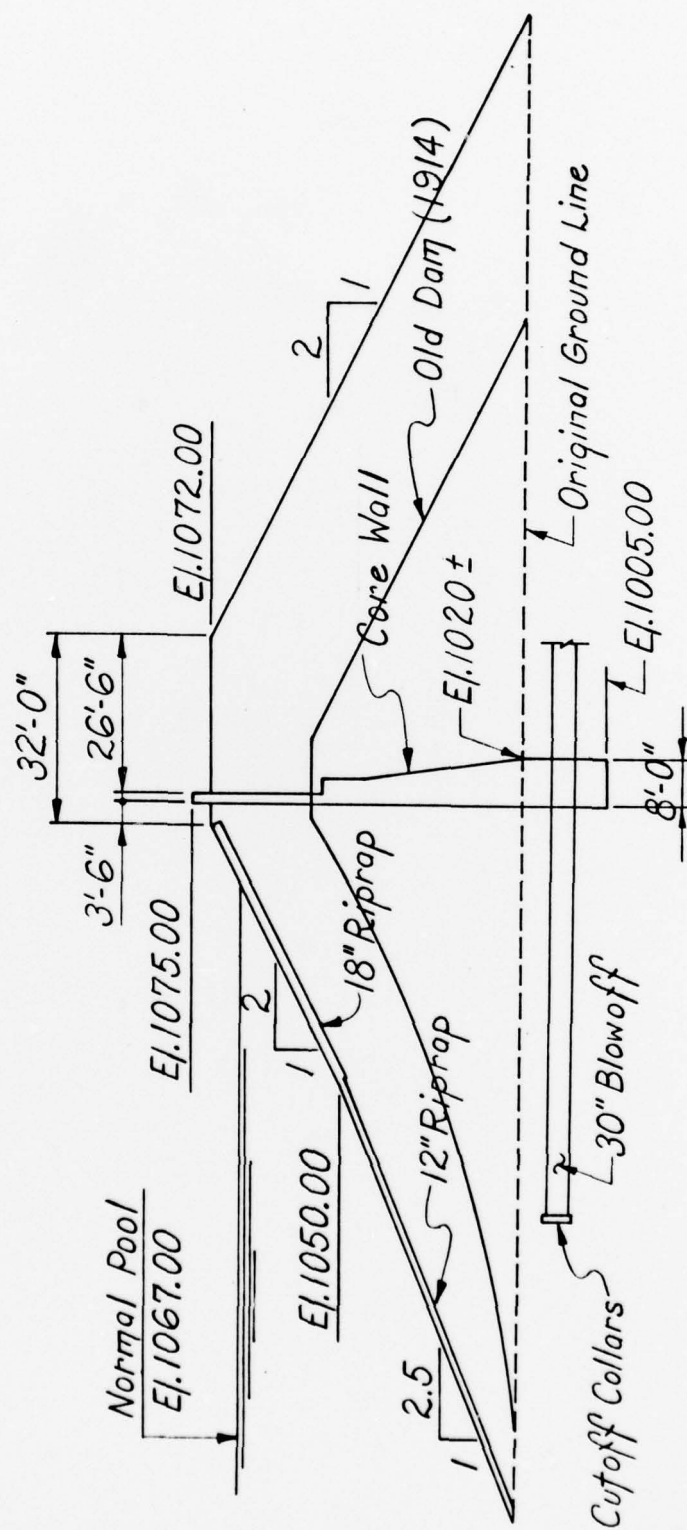
(1924)
TYPICAL DAM SECTION
 Scale: $1" = 30'-0"$

There were no design criteria or design data available for review. The typical section shown on Plate VI, Appendix D, indicates a well engineered section with a concrete core wall extending to rock surface. The specifications for the 1924 raising of the dam specified a good contact with the rock strata and that grouting was to be used. All structures appear to be in good condition, indicating good construction.
